TITLE: FUSELAGE. FUSELAGE TO WING FAIRINGS. INSPECTION OF THE SKIN AND

THE FRAME C.5F IN THE CENTER WING FAIRINGS AREA.

DATE: 2018-11-05 SERVICE BULLETIN No.: SB-212-53-0054C REVISION No.: 00 Page: 3

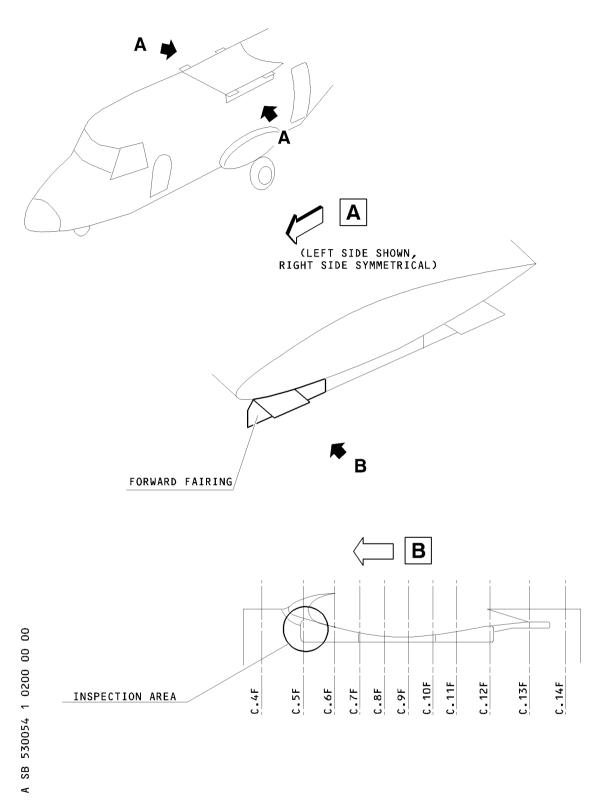
Figure 2 - Sheet 01 Location of the Inspection Area.

(a) Do a Detailed Visual Inspection (DVI) of the skin and the frame C.5F in the center wing fairings area.

(a) Remove and keep the forward, left and right fairings under the center wing. Refer to FIG. 2 Sheet 01.

(a) Install the kept forward, left and right fairings under the center wing. Refer to FIG. 2 Sheet 01.
